9 April 2024

General Motors Position Statement Bumper/Fascia Replacement with Advanced Driver Assistance Systems (ADAS)

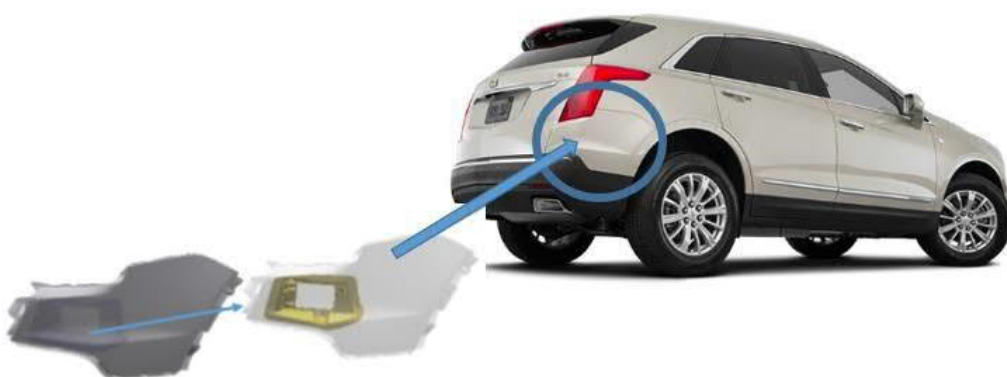
Figure 1.1

Depending on vehicle build configuration, the Bumper/Fascia system may have ADAS sensors attached to the inner surface that are not visible from the exterior of the vehicle (Please refer to Figure 1.1). GM is limiting repairs to these Bumper/Fascia systems on vehicles equipped with ADAS.

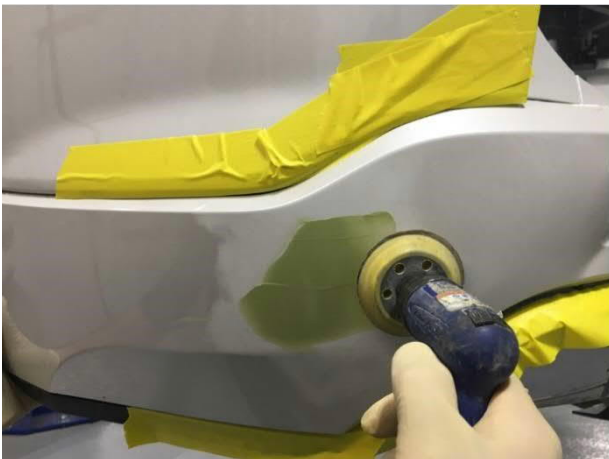
Any Bumper/Fascia equipped with ADAS(s) that requires substrate repair must be replaced. An example of substrate repair is shown in Figure 1.2
